REPORT NO. DRXTH-IS-TR-81-108

SURVEY OF THE FORMER NIKE SITES LOCATED AT NORTH SMITHFIELD, FOSTER AND COVENTRY, RHODE ISLAND

June 1981

Final Report

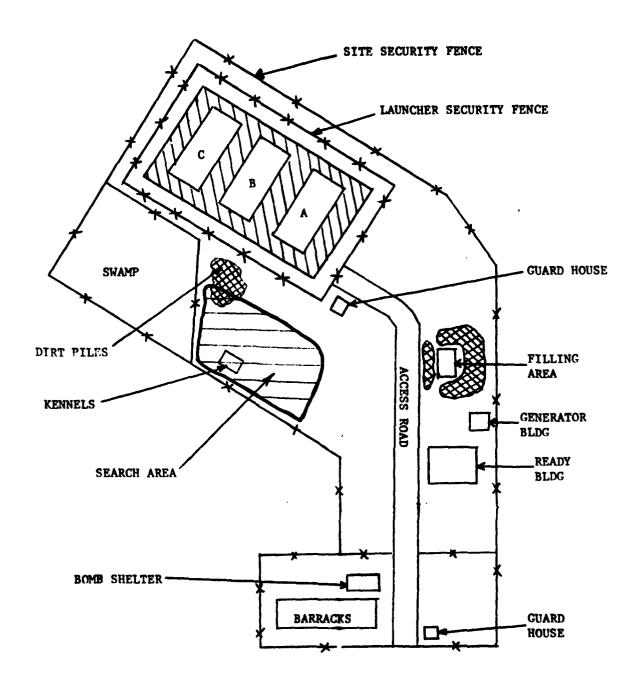
FIG. 10. NORTH SMITHFIELD LAUNCHER SITE

The search began with the incremental digging of a 3-foot deep trench immediately adjacent to the fence. Remaining passes were conducted perpendicular to the fence. A total of three canisters and one set of filling hoses were found, all near the kennel area. (This is the same area where other containers had been uncovered previously.) One can was olive drab, two were silver. Cans were collected in a covered barrel of water to await disposal. As an extra precaution, the kennel area was dug down to a total of nearly 5 feet. When the survey was complete, the cans were disposed of by incineration. They burned for approximately 4 minutes, with a intense yellow-orange flame which indicated the presence of UDMH. The site was then backbladed approximately level.

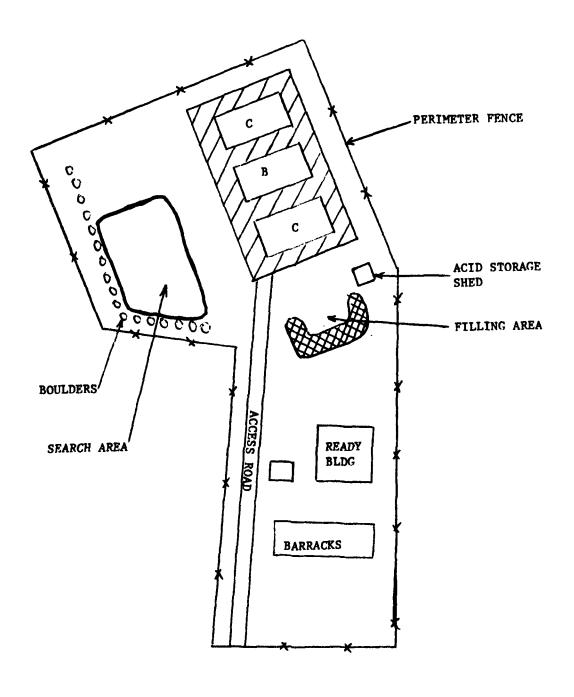
FIGURE 11. FOSTER LAUNCHER SITE

Before the search of the field could begin, the larger boulders had to be removed with the ripper on the back of one dozer. This removed all boulders greater than 3 feet in diameter. The incremental search (with the blade) was then conducted to an average depth of at least 3 feet. One silver UDMH canister was found between A and B batteries, approximately 45 feet from the fence. It had no cork, liquid, or odor, and was, therefore, considered inert. Finally, the site was backbladed; the backblading met with limited success due to the remaining boulders strewn throughout the field.

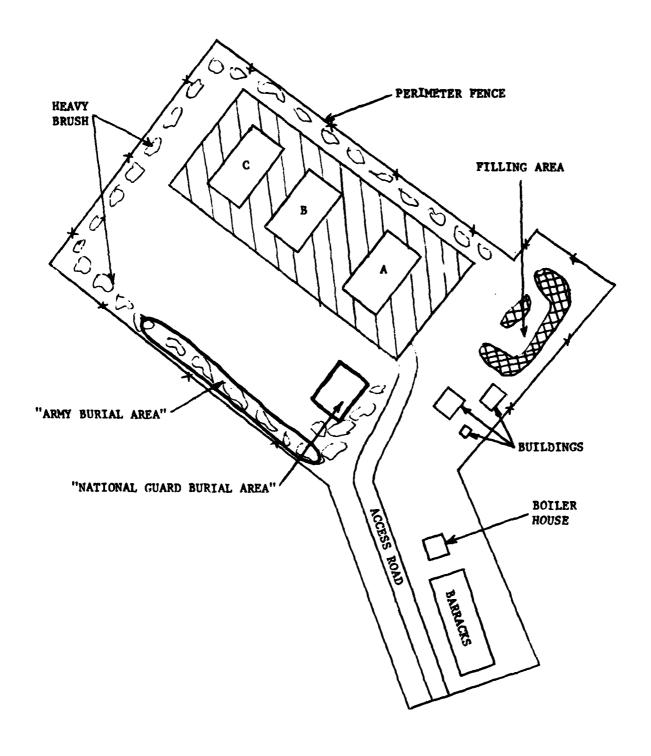
FIGURE 12. COVENTRY LAUNCHER SITE

The major source of burial information on the Coventry Site was Mr. Bestwick. He visited the site several times with USATHAMA personnel, and specified two search areas; one, where he personally buried canisters while in the Army, and the other, where an unidentified friend reported having seen canisters buried while he (the friend) was stationed there in the National Guard. These two areas are shown on Figure 12.

The final site investigated was Coventry. The first area searched was the supposed "National Guard Burial Area," located at one edge of the open field. An additional, diagonal trench was dug in this area to a total depth of about 6 feet, and an additional shallow trench dug behind the area. No cans were found in these additional trenches. No metal targets could be found in the excavating. The search of the supposed "Army Burial Area" (along the fence) yielded two shiny aluminum cans, found together directly opposite B launcher. One can was full of liquid and the other was empty. The full can was incinerated and produced the characteristic, intense orange-yellow flame.
